CHIMNEYS AND LINING

WHAT IS CHIMNEY LINING?

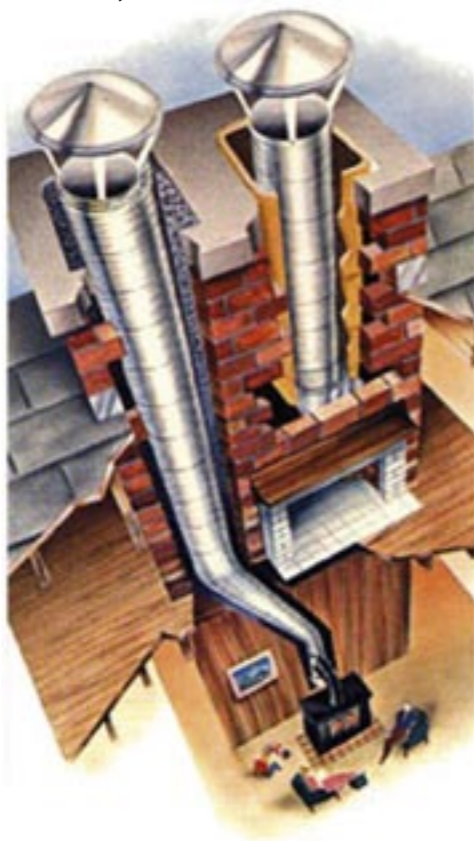
The illustration to the left shows two types of chimney system lining.

- **Flue.** The void or passageway through which the products of combustion are removed from the fire to the outside.
- **Chimney.** The structure surrounding one or more flues.
- **Flue liner.** The material used to form the flue or flues within a chimney.
- **Chimney terminal.** This is the pot, cowl or other method of finishing the top of the chimney.
- **Flue pipe.** A metal pipe used to connect an appliance to the flue in a chimney.
